# Tuning in

Venue acoustics can be vastly improved without the need for costly downtime and extensive disruption to artists and audiences

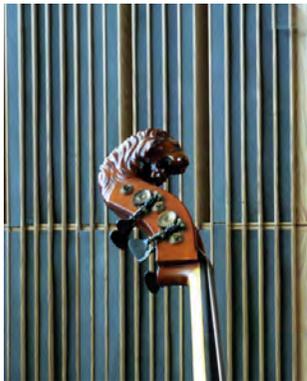
**Left:** The loudness on stage was further controlled by strategically adding absorption to existing perforated or slatted finishes. Some areas remain untreated for beneficial reflections

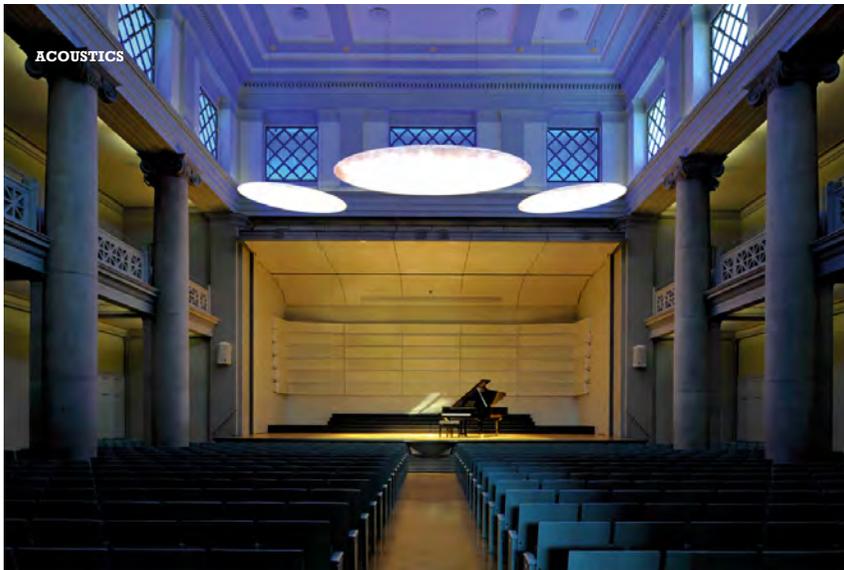
Above: **Stadthaus Winterthur in Switzerland with the new stage shell. The ellipsoidal lights provide reflections back to the musicians and to audience in the stalls. Photo: Karl Fülischer for Architekturbüro Johann Frei**

In both projects, the addition of acoustical absorption close to the loudest instruments reduced sound levels. Acoustical projection and communication on stage were improved by tuning and/or installing sound reflecting surfaces. Expert feedback from artists was key to developing solutions that could be implemented with minimal disruption to the orchestra – for example, the new stage shell at Winterthur was installed in only two weeks.
